INVESTIGATIONS OF THE HISTORIC SOUTH RIVER WOOD DISTILLATION/CHARCOAL PLANT SITE

FINAL

MARCH 1992

CH2M Hill Engineering Ltd.

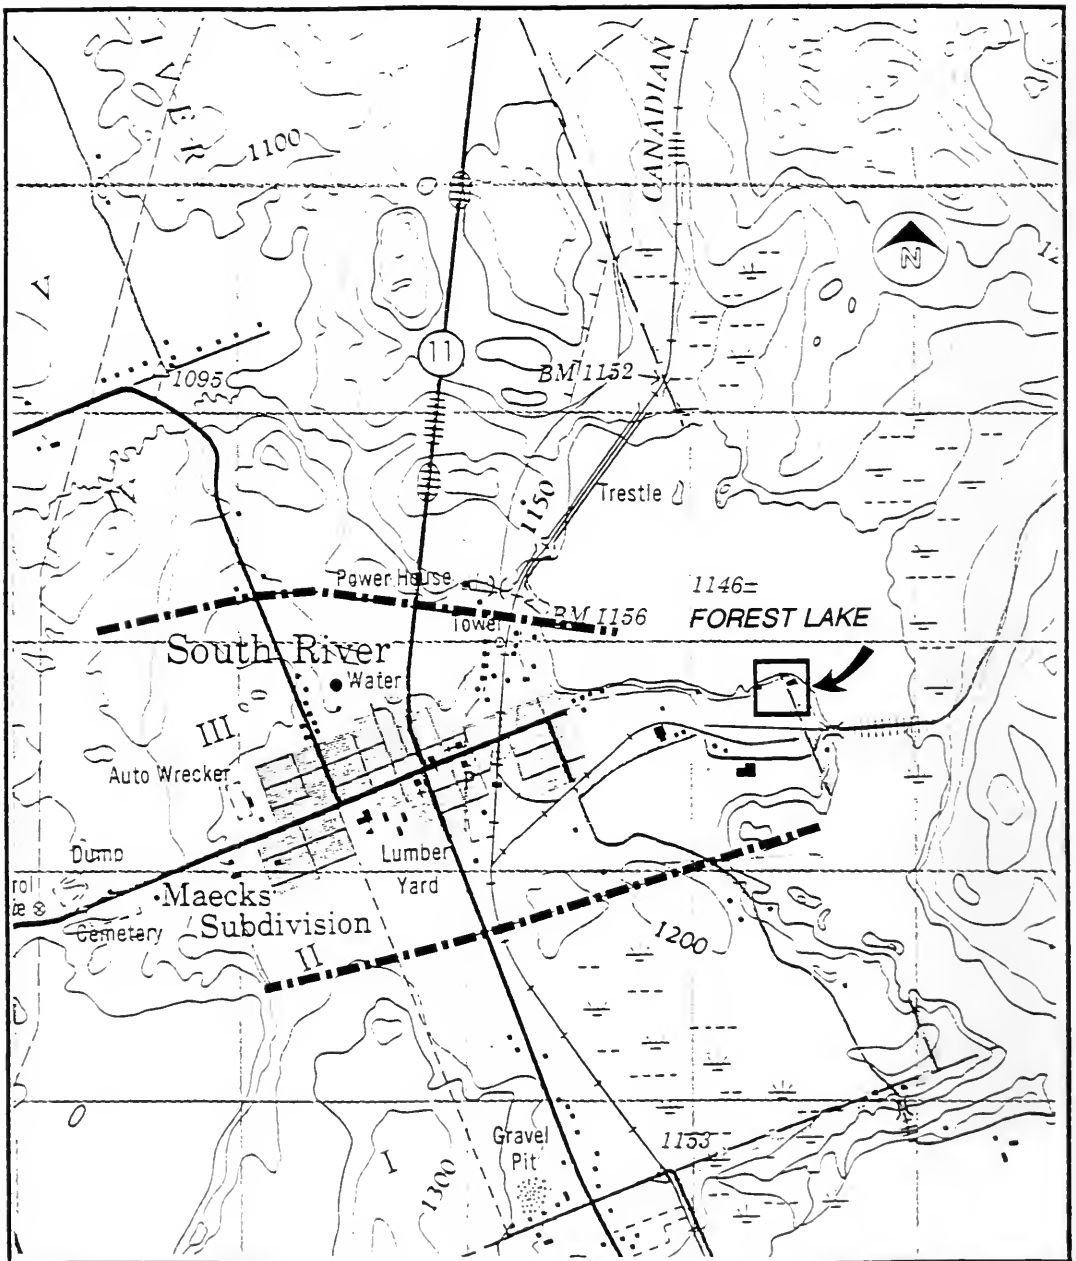
Figure 5: Location of Buried Bedrock Valley, South River Area

A buried bedrock valley runs underneath the village (Figure 5). The buried valley trends east-west, is approximately 1 km wide, and presumably extends underneath Forest Lake. The depth to bedrock is up to 85 m in the deepest parts of the buried valley. The overburden filling the valley is up to 60 m of clay, silt, sand and boulders, overlain by up to 25 m of primarily fine to coarse sand. The location of the buried valley was defined using local water well records (Geo-Environ, 1978) and geophysical resistivity surveys conducted in 1977 by the MOE (unpublished report, MOE files).

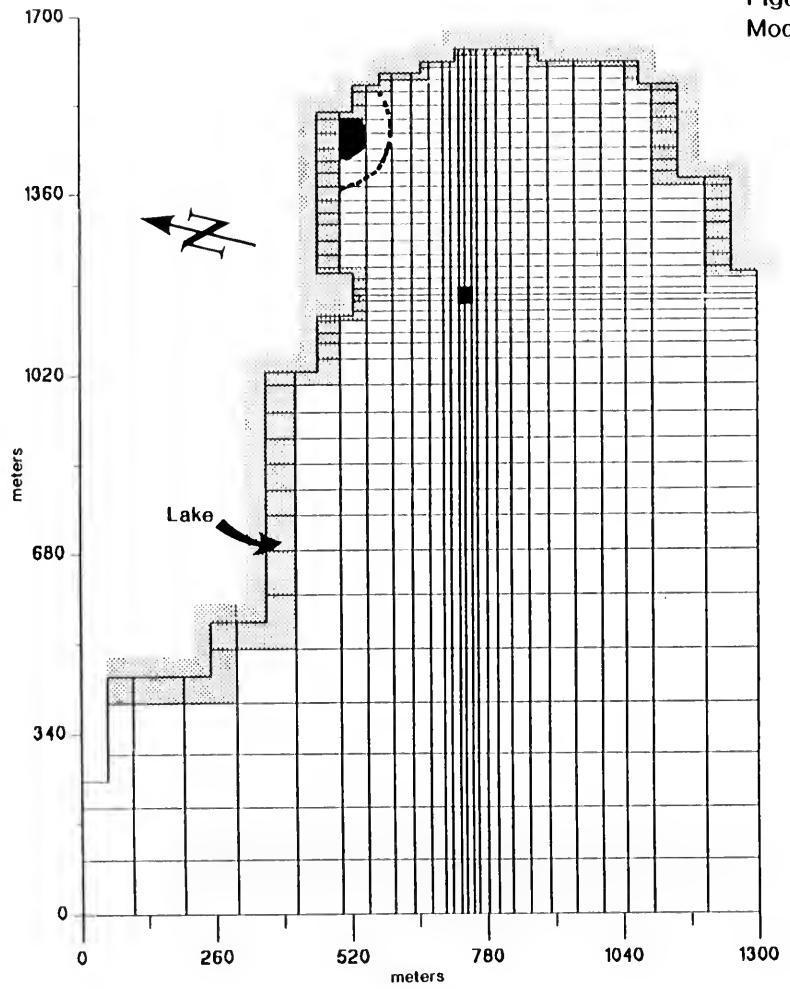
Figure 8:
Model Simulation Domain and Grid

The model simulation domain is shown in Figure 8. The edges of the aquifer were taken to be: Forest Lake on the northeast and east; the boundary of the bedrock valley on the south and the southwest; and an arbitrary boundary on the west, far from

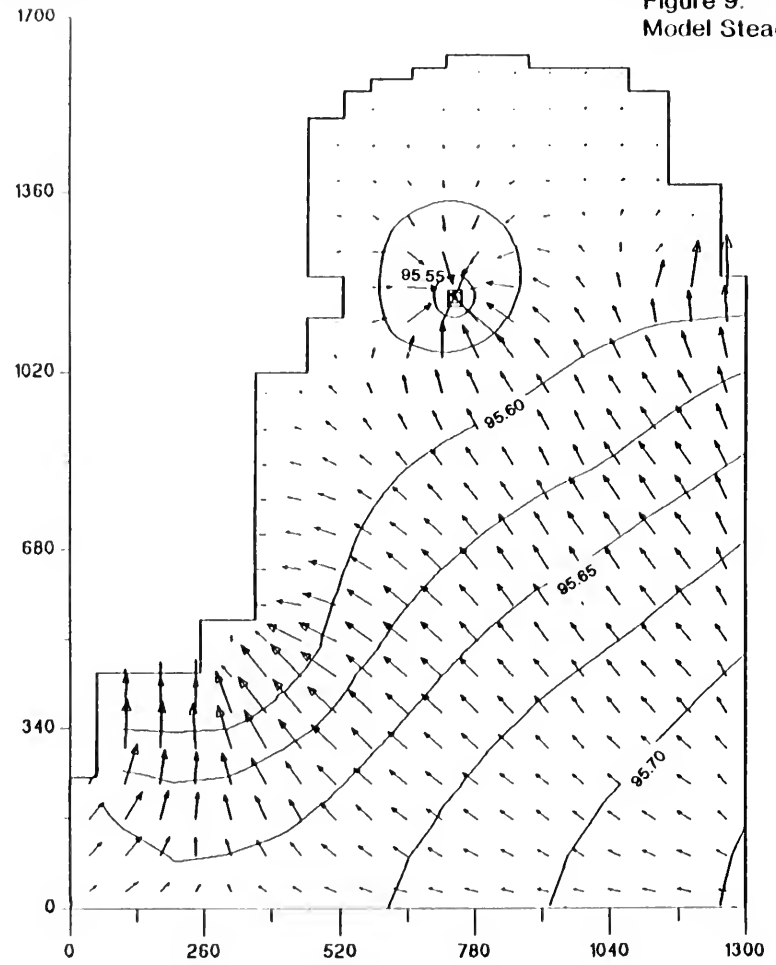
Figure 9:
Model Steady-State Groundwater Flow Solution

The steady-state groundwater flow regime calculated by the model is shown in Figure 9. There is regional groundwater flow in a northerly direction, ie. towards the lake. Superimposed on this regional flow pattern is the effect of the municipal well. A "drawdown cone" is evident around the well, where groundwater flows towards the well.

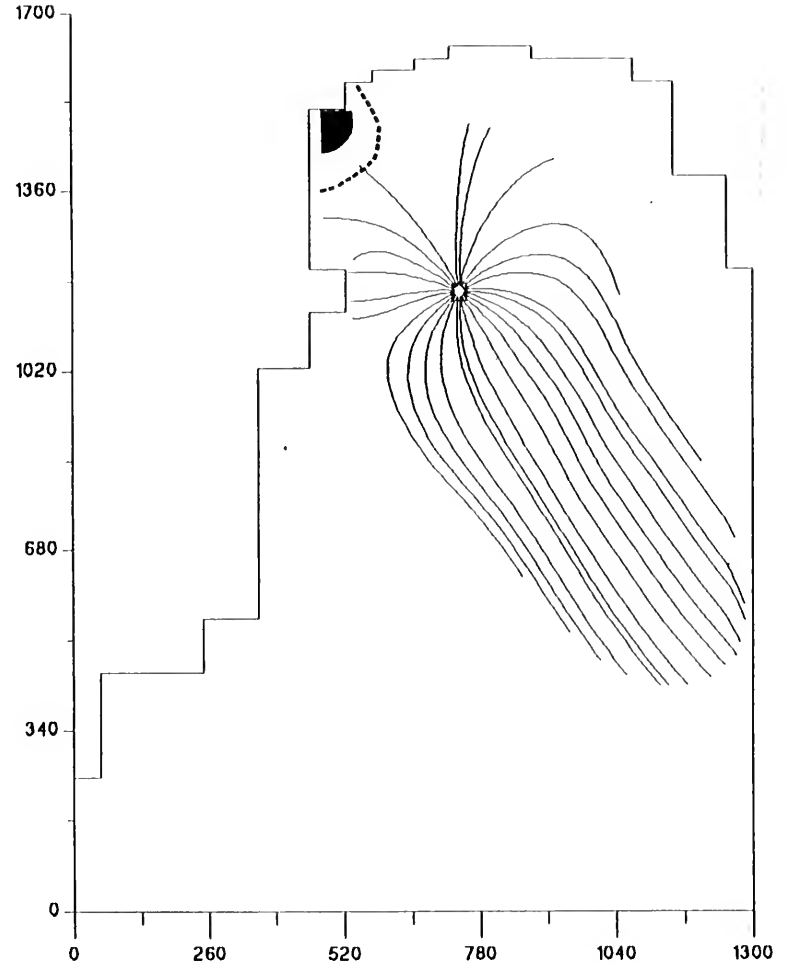
Figure 10:
Well Capture Zone: 25 years

The results of the model indicate that, under current conditions, the site area is likely to lie within the capture zone of the municipal wells. However, the model indicates a travel time of 25 to 50 years for groundwater now underneath the site to travel to the municipal wells. The municipal wells have presently been in operation for about 10 years. Model simulations indicate that groundwater underneath the former tar pit area would only travel 50 to 200 m towards the municipal wells in the first 10 years of pumping. This is not inconsistent with the observed limited extent of groundwater contamination underneath the site.

Area of groundwater contamination

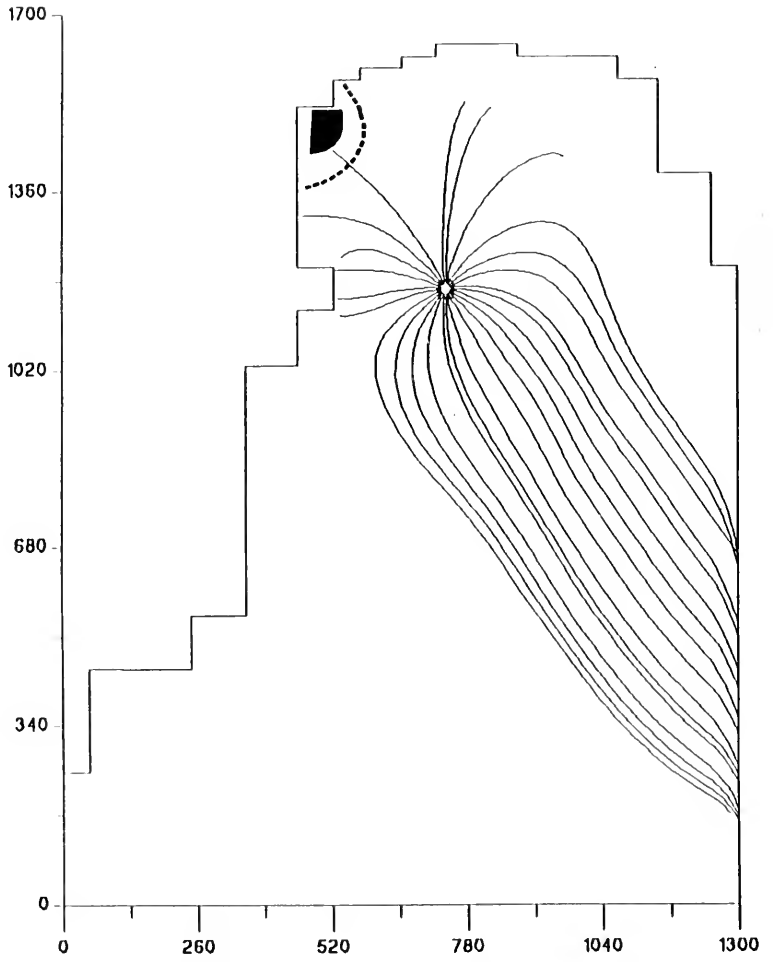
Figure 11:
Well Capture Zone: 50 years

Area of groundwater contamination

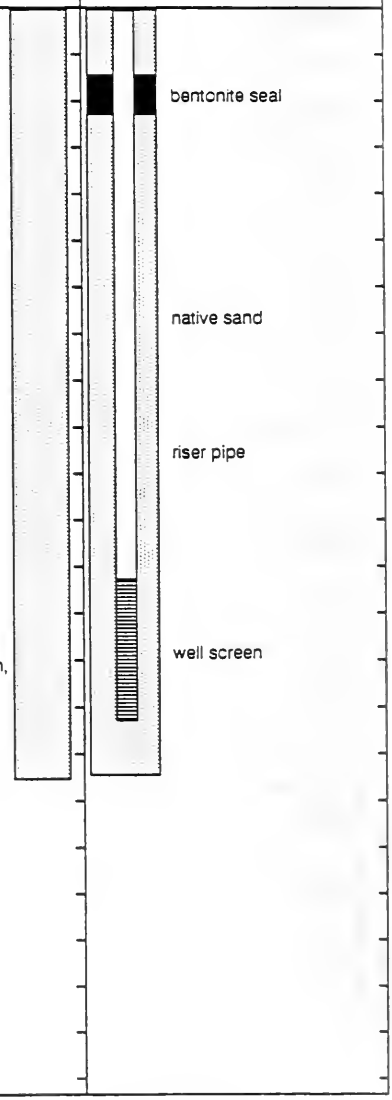
PROJECT NUMBER	WELL NUMBER	
ONT29344.AO	MWN1B	PAGE 1 OF 1

MWN1B — Located in the area of the former tar pond, at a depth of about 8 m below ground surface. Groundwater at this location contained detectable levels of xylene, PAHs, and Phenolics. Only naphthalene and total phenols were found in concentrations exceeding guidelines (CCME guideline A and MOE. MDC, respectively). Water from this well had a distinct odour, and the water foamed as it came into contact with the atmosphere.

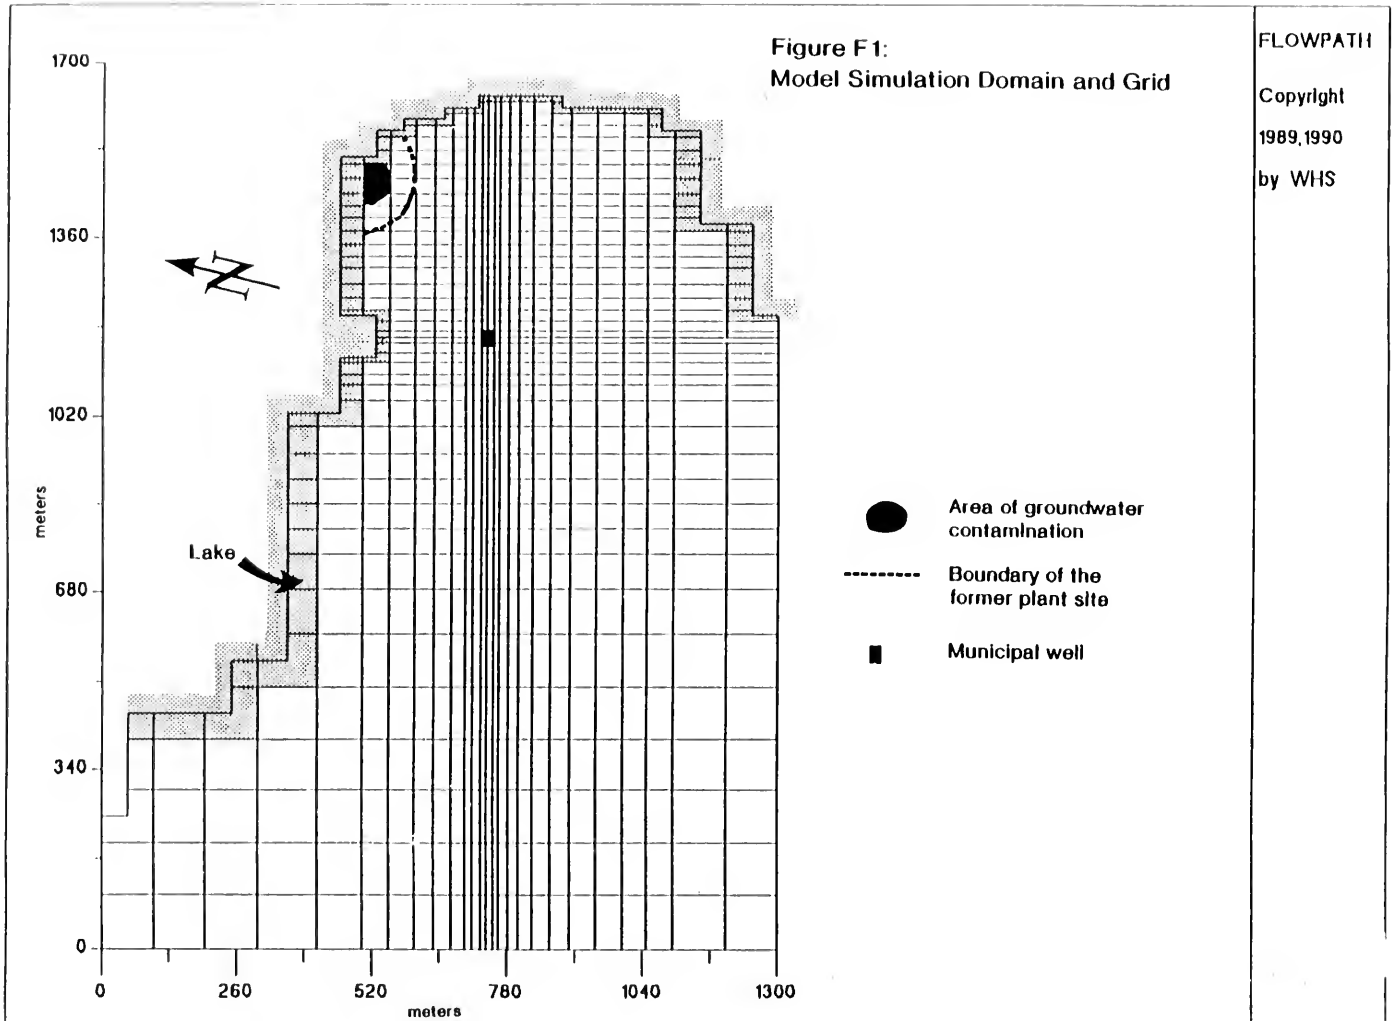
Figure F1:
Model Simulation Domain and Grid
FLOWPATH
Copyright
1989,1990
by WHS
1700
1360
1020
680
340
0
meters
Lake
N
0
260
520
780
1040
1300
meters
Area of groundwater contamination
Boundary of the former plant site
Municipal well
